STATE OF CALIFORNIA
DEPARTMENT OF PUBLIC WORKS
DIVISION OF HIGHWAYS

MEDIAN BARRIERS
ONE YEAR'S EXPERIENCE
AND
FURTHER CONTROLLED FULL SCALE TESTS

Presented at the 41st. Annual Meeting of the
Highway Research Board, Washington, D.C.
January, 1962

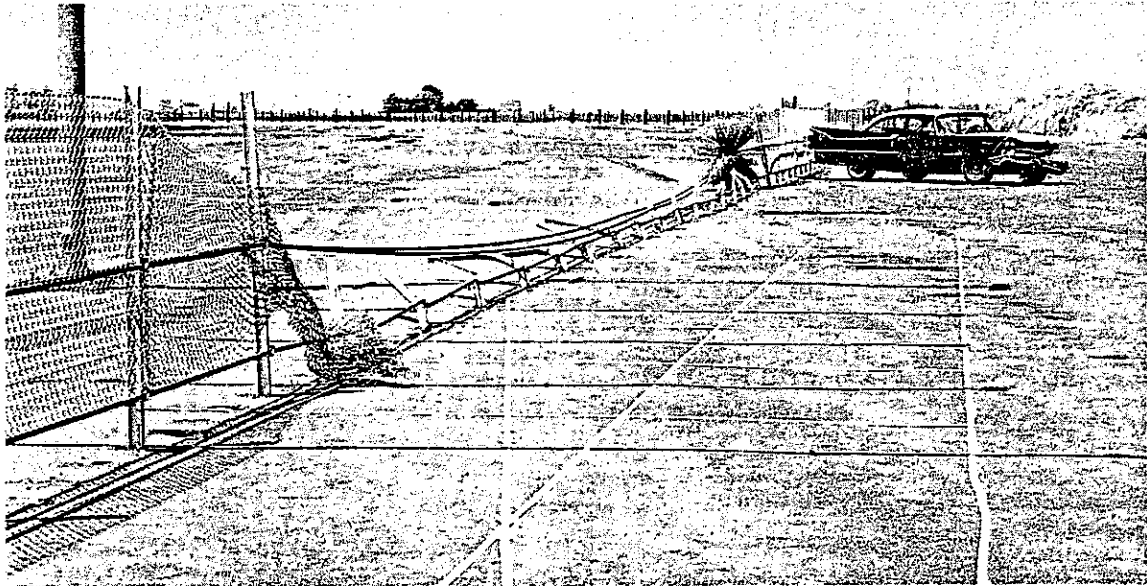
TEST NO. 1

Barrier Damage: Approximately 130 feet of mesh gathered up between top cables at point of spin-out. No cable fitting damage or failures. Damage was typical of that recorded during 1959 test series. Slight cracking of post footings was result of "green" concrete. No posts pulled out of footings. There was no appreciable movement of the post footings.

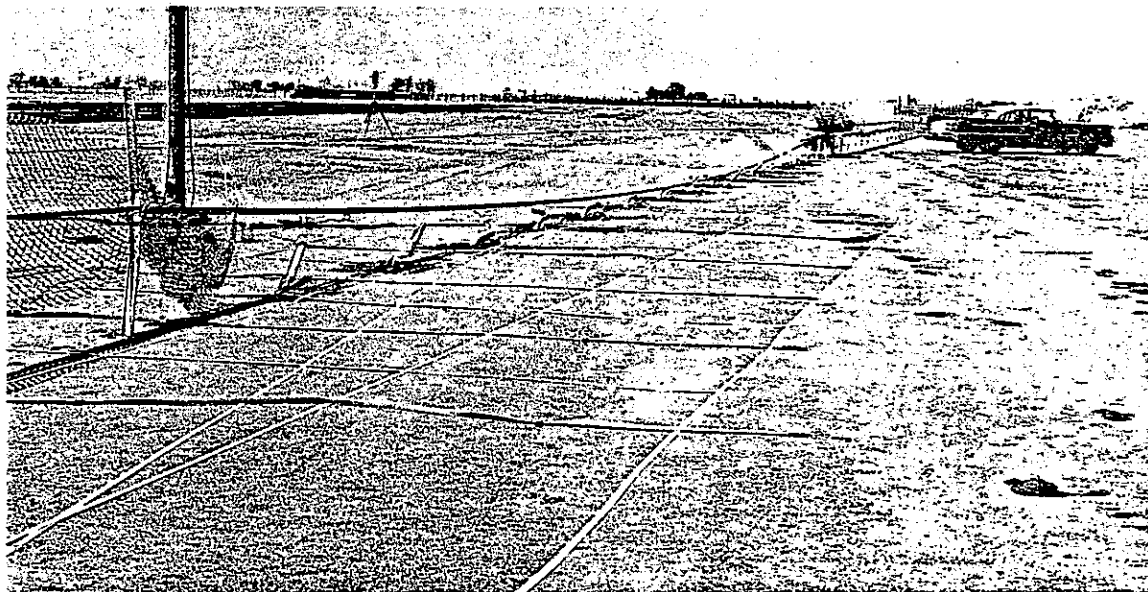
TEST NO. 2

Barrier Damage: Approximately 130 feet of mesh gathered up between cables at point of "spin out". Fabric and post damage was very similar to that of Test No. 1. Slight cracking of post footings was result of "green" concrete. No posts pulled out of footings. There was no appreciable movement of the post footings.

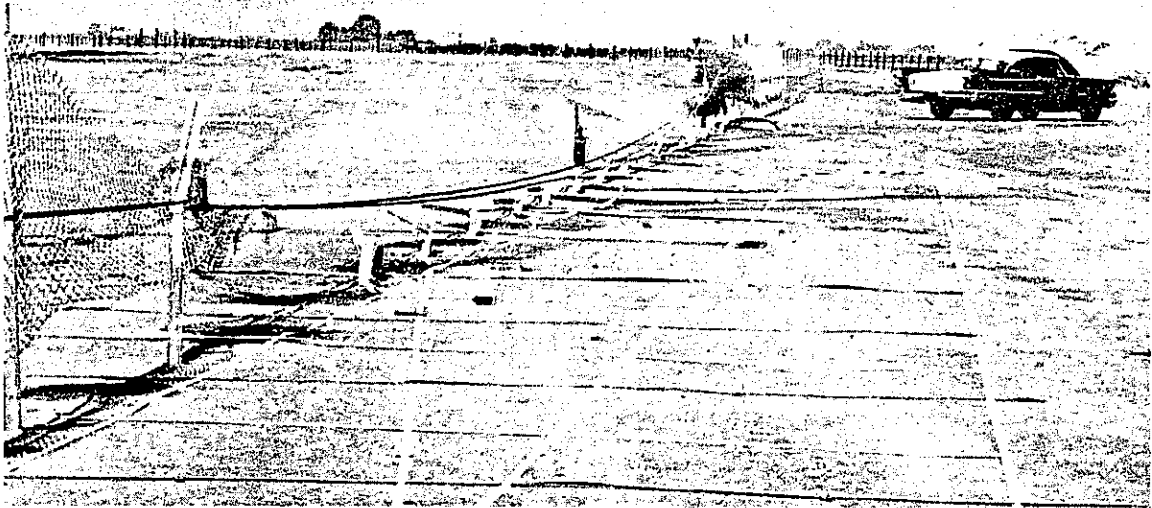
TEST NO. 3

Barrier Damage: Approximately 125 feet of mesh gathered up between cables at point of spin-out. Fabric and post damage was very similar to that of Tests No. 1 and 2. One post pulled out of socket footing. Twenty posts pulled between 1/2 inch and 2 inches out of sockets. Slight cracking of footings was not severe enough to prevent re-use on Test No. 5.

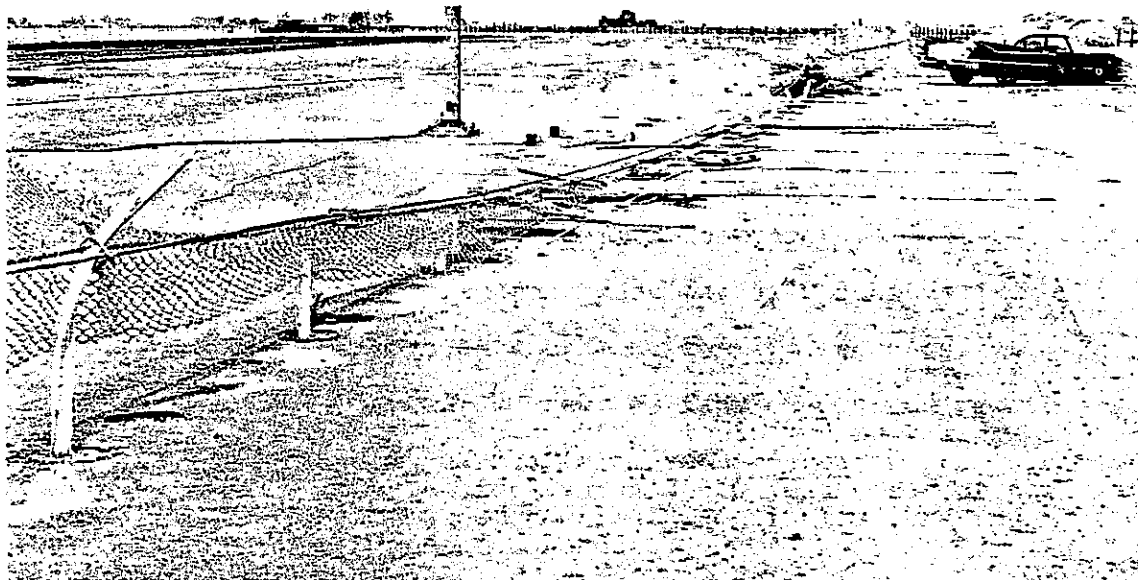
TEST NO. 4

Barrier Damage: Approximately 90 feet of fabric gathered up between cables at point of "spin out". There was no failure of the turnbuckles; however, the cable was badly kinked adjacent to the cable pull on the front turnbuckle (impact side) and also 10 feet ahead of point of spin-out where post had pulled out of footing. Footing failure and cracked footings were result of "green" concrete.

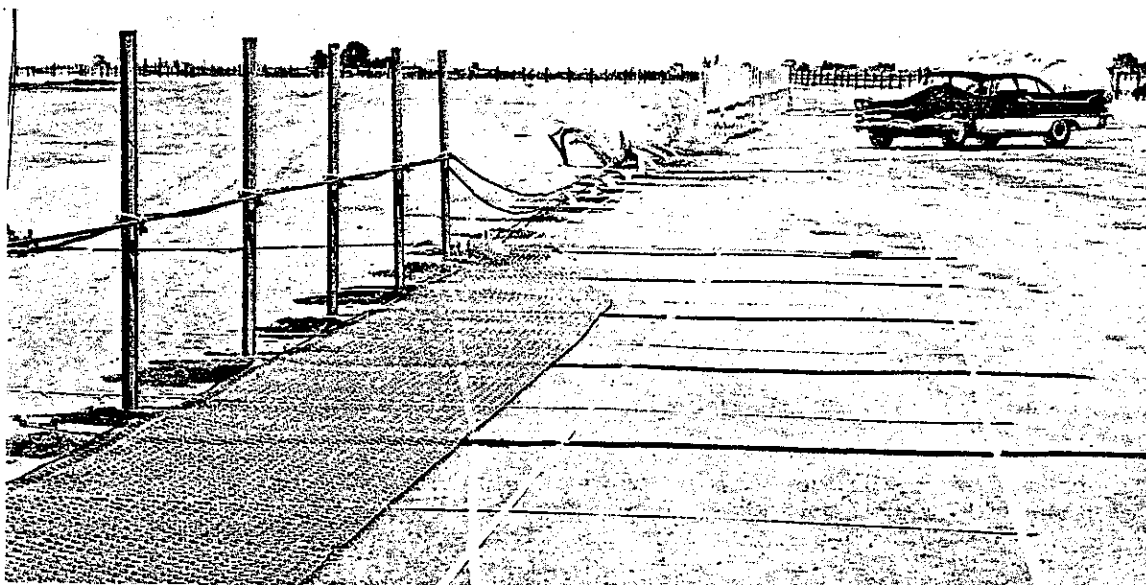
TEST NO. 5

Performance: See Exhibit 8. Car started "spin-out" approximately 70 feet from point of impact due to posts #2 and #3 pulling out of sockets and jamming at the second turnbuckle located 58 feet ahead of impact. Posts, clamps and fabric passed over first turnbuckle located 50 feet ahead of impact and jammed on second turnbuckle. The vehicle carried entire bundle 10 feet further as dead-end located 100 feet behind point of impact failed. Fabric fastened with 12 gage steel tie wires was torn from posts for 70 feet behind point of impact and fell to pavement.

Barrier Damage: Preformed dead-end failed under extreme loading caused by posts and clamps jamming on turnbuckle. The dead-end had been removed from a cable used on a previous installation. During removal, a critical amount of aluminum oxide coating was stripped from the inside of the weave resulting in insufficient friction for the assembly to retain the cable under normal collision loads. Socket type post footings from Test No. 3 were re-used for this test. No additional cracking was noted.

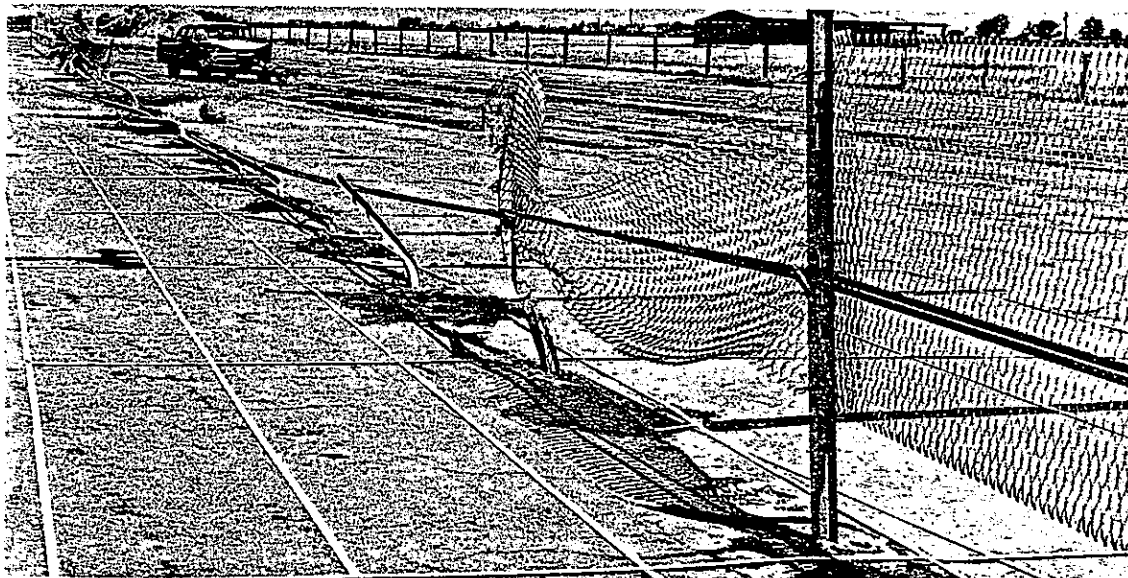
TEST NO. 6

Barrier Damage: Fourteen panels (112 feet) of expanded metal gathered up at point of spin out. The severe cracking of all post footings in the collision zone and complete failure of one was due to "green" concrete.

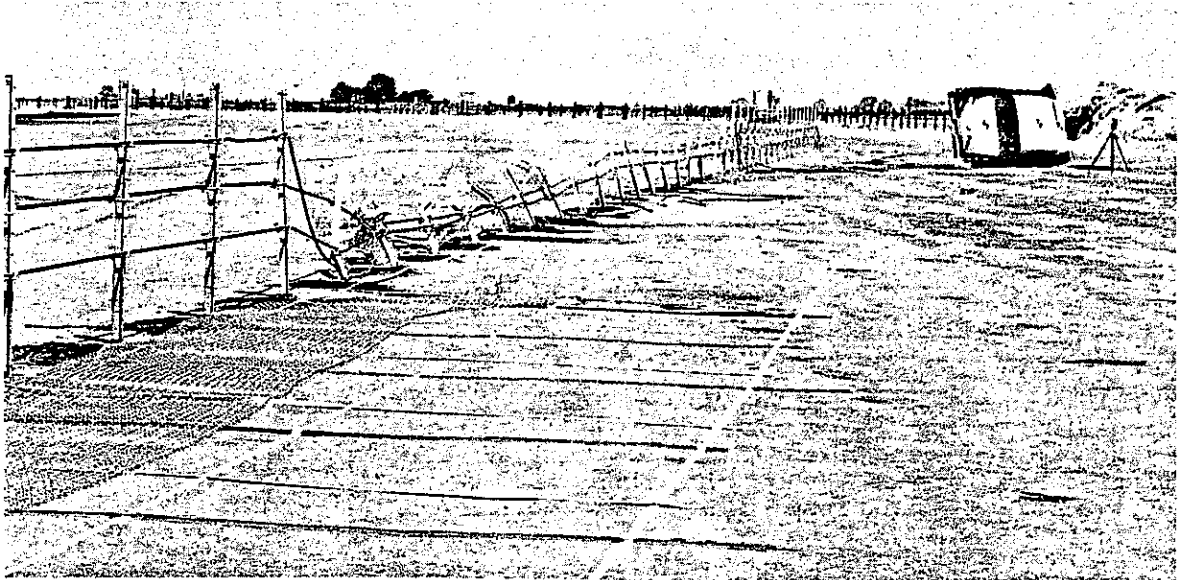
TEST NO. 7

Barrier Damage: The preformed cable splice located 125 feet ahead of impact failed as the windshield post sliding along the cable passed the frayed ends of the splice. At this location, the failure had no appreciable effect on the vehicle reaction; however, had the splice been installed 20 feet closer to the point of impact, the vehicle would have rolled over the barrier as the splice released.

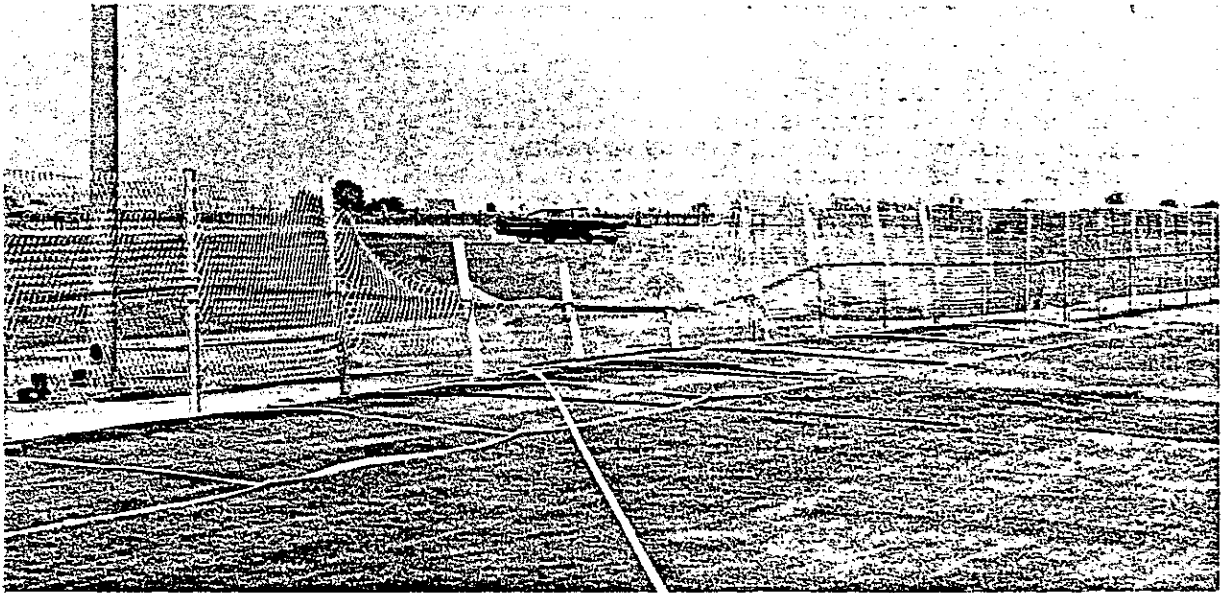
TEST NO. 8

Performance: See Exhibit 11. The vehicle left the crown of the ramp and traveled airborne 17 feet to point of impact. Data films show that the vehicle had dropped only 2 inches along the trajectory from the crown of the ramp to the barrier. At the point of impact, the cables were below the center of the bumper at an effective height of 20 inches. The bumper contacted the post forcing it back and down and the cable was carried down with the post. The left front tire contacted the barrier at an intersection of post and cable further forcing the cable down and rolling over with no tendency to snag. As the vehicle progressed across the barrier each wheel was successively forced into its wheel well. There was no tendency for any part of the vehicle to snag on the cables. The 7 gage tension wire cracked the top of the windshield before failing at the 3/8 inch turnbuckle located 150 feet behind the point of impact.

Barrier Damage: Post collision height of cables at point of impact was approximately 8 inches above the crown elevation of the simulated super. No post footings were cracked.

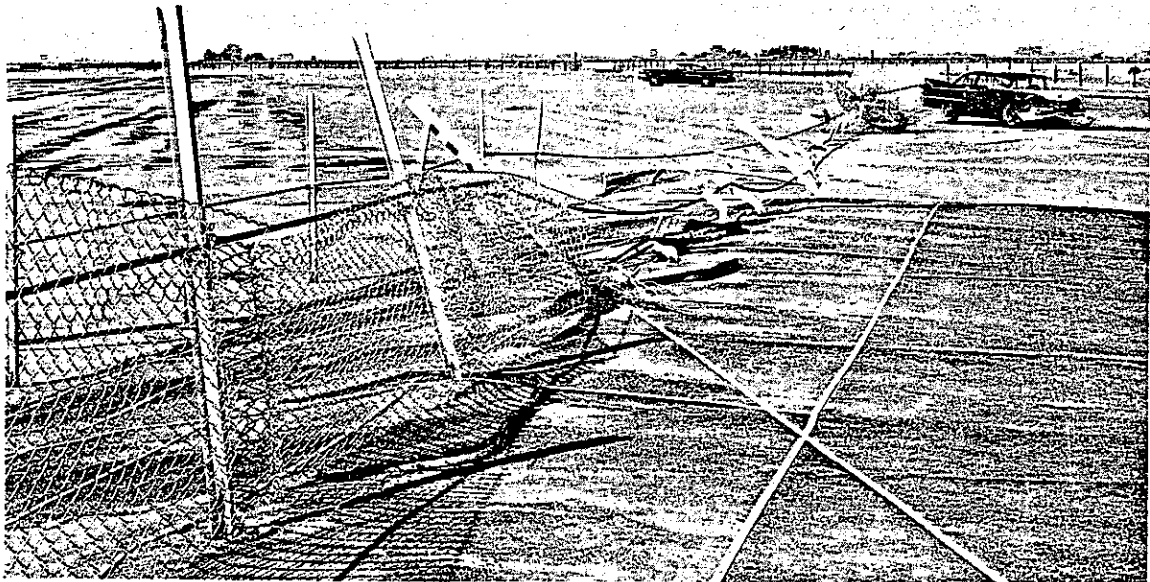
TEST NO. 9

Barrier Damage: 125 feet of fabric was gathered up at point of spin out. Seven post footings were cracked due to "green" PCC. None of the posts were moved from the asphalt filled sockets.

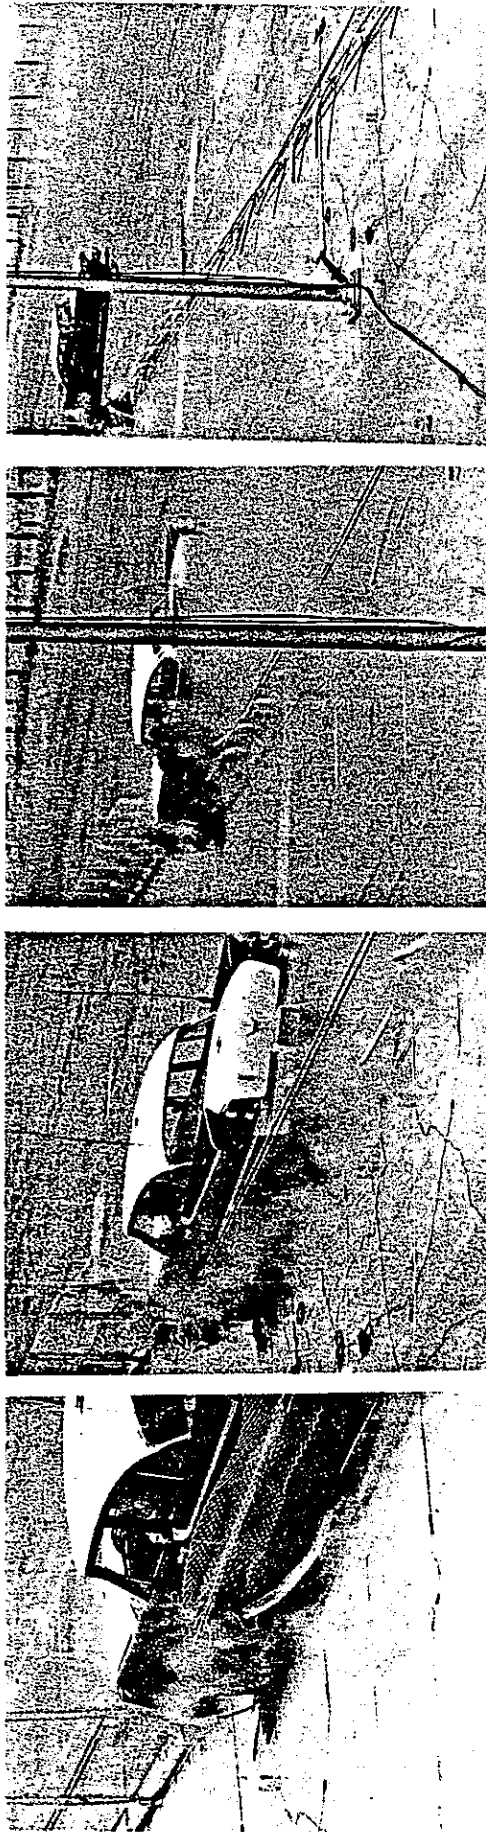
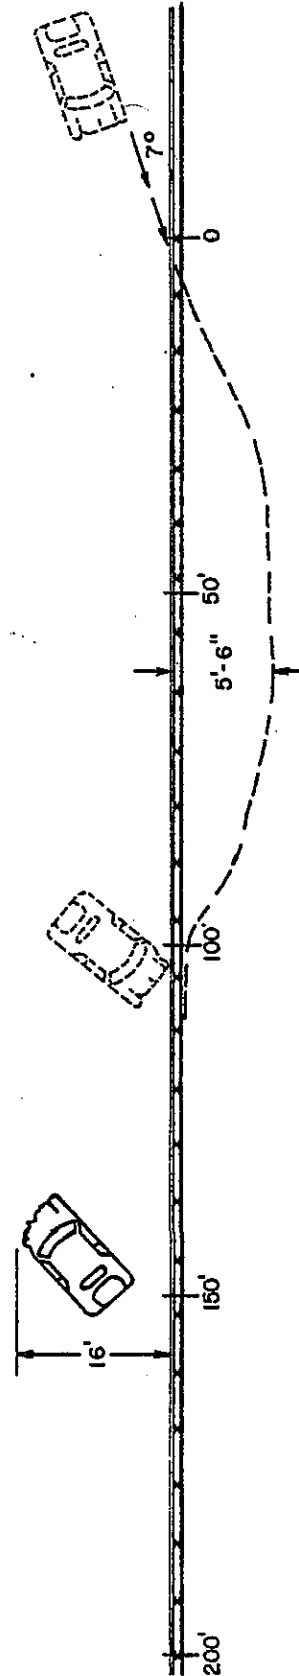
TEST NO. 1
 DATE 6-8-61
 VEHICLE Dodge 59 Sedan
 SPEED 78 MPH
 IMPACT ANGLE 7°
 VEHICLE WEIGHT 4300 lbs.
 (W/DUMMY & INSTRUMENTATION)

FENCE	48" chain.	FENCE DAMAGE	152' damaged
	link at 9" above pavement.	CABLE FITTING DAMAGE	none
CABLE	3/4" 6x19 IWRC 1	CABLE DAMAGE	none
	at 9" and 2 at 30" above pavement.	POST DAMAGE	19 damaged
POST FOOTING	Design A	POST FOOTING DAMAGE	7 cracked
POST SPACING	8' O.C.	MAX DYNAMIC DEFLECTION OF CABLES	5 1/2
LENGTH OF INSTALLATION	600'	VEHICLE DECELERATION (PEAK LONG)	6.5g's
GROUND CONDITION	Dry	VEHICLE DAMAGE	\$ 350

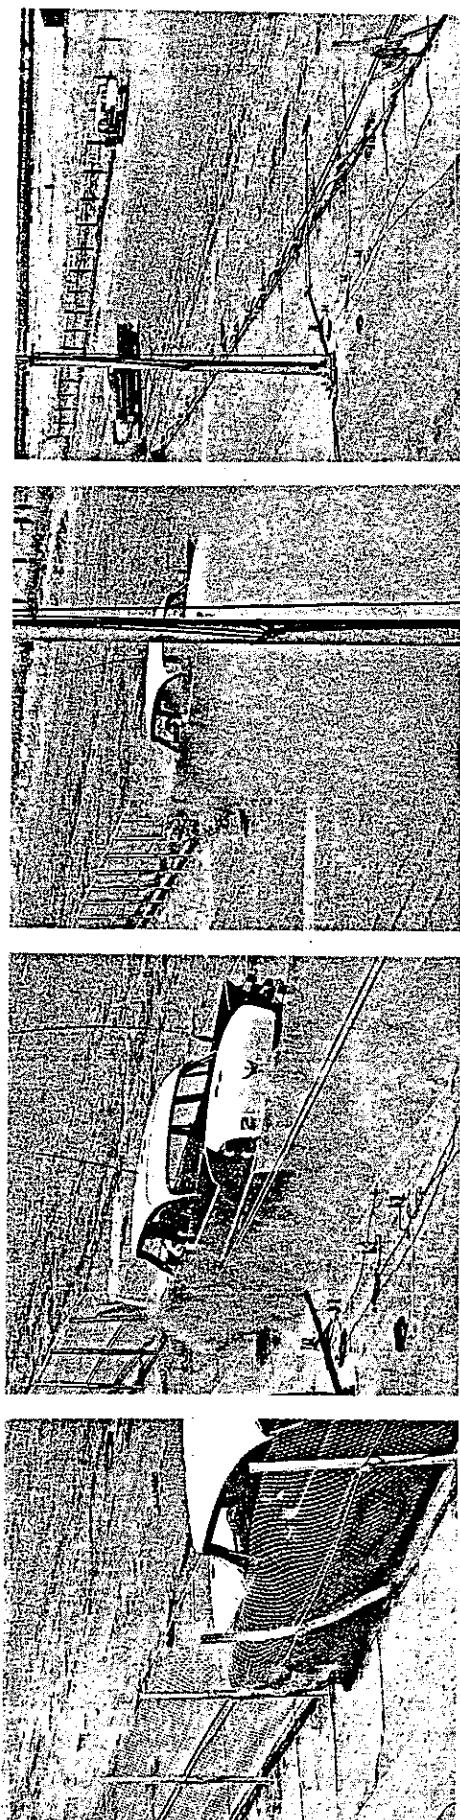
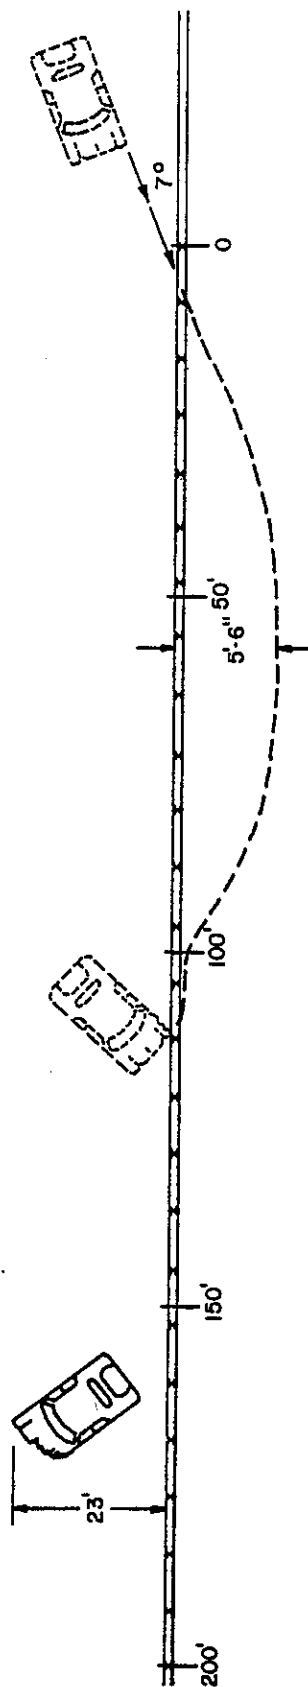
FENCE DAMAGE 140' damaged
CABLE FITTING DAMAGE none
CABLE DAMAGE slight fraying
POST DAMAGE 19 damaged
POST FOOTING DAMAGE 12 cracked
MAX. DYNAMIC DEFLECTION OF CABLES .. 6'
VEHICLE DECELERATION (PEAK LONG.) .. 2.4 g's
VEHICLE DAMAGE \$ 350

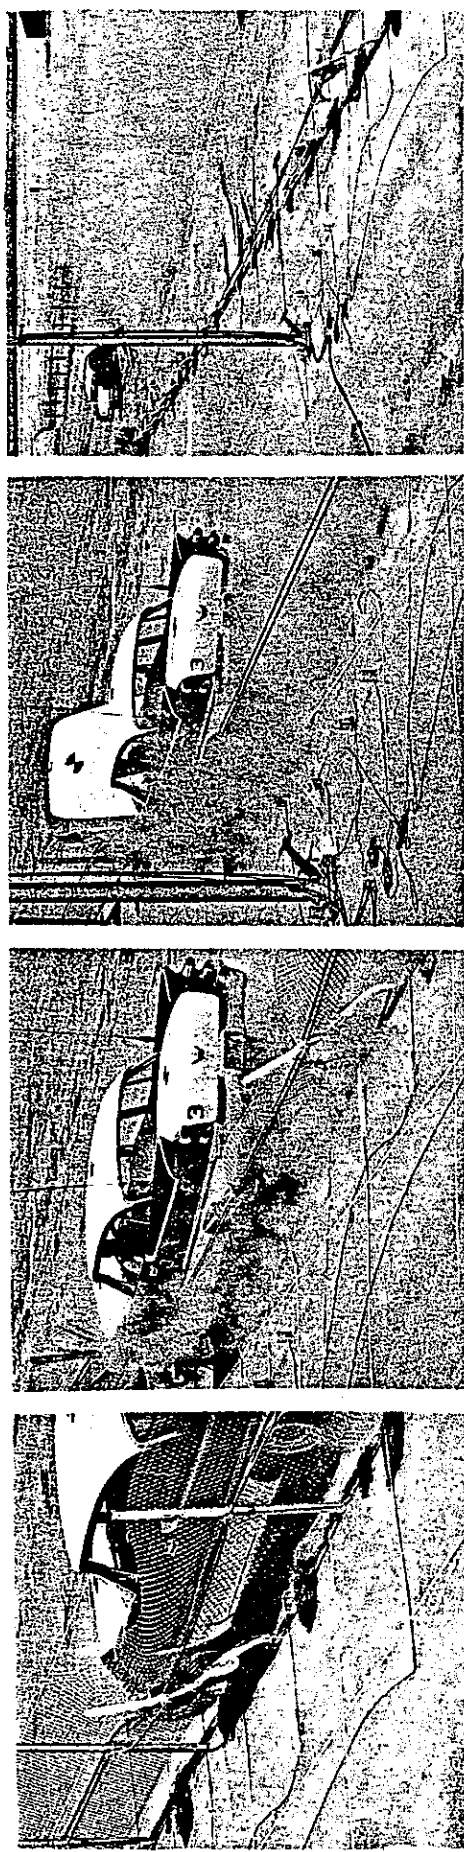
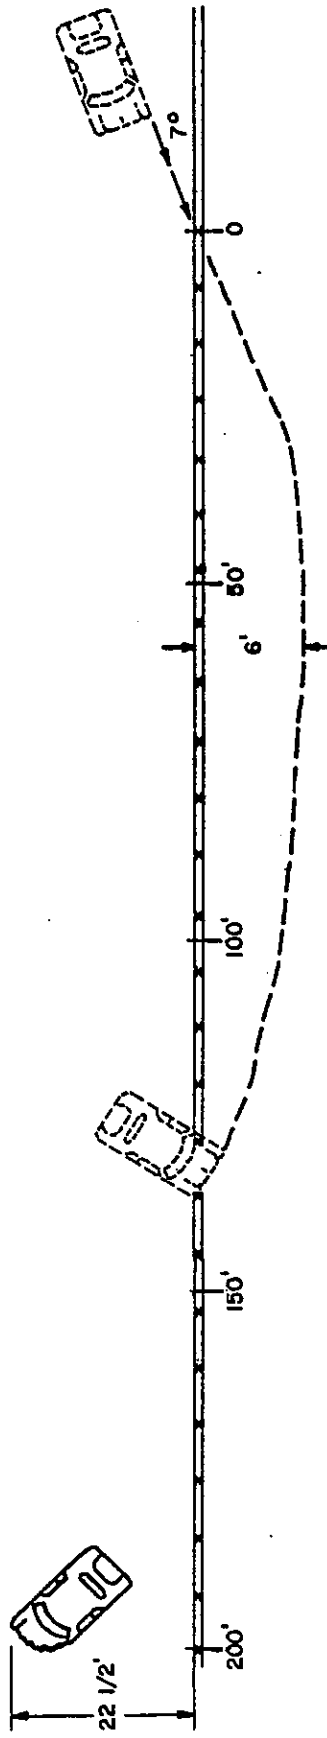
TEST NO.....	3
DATE.....	6-19-61
VEHICLE.....	Dodge 59 Sedan
SPEED.....	86 M.P.H.
IMPACT ANGLE.....	7°
VEHICLE WEIGHT.....	4300 lbs.
(W/DUMMY & INSTRUMENTATION)

FENCE.....	48" Chain link	FENCE DAMAGE.....	152' Damaged
	at 9" above pvmf.	CABLE FITTING DAMAGE.....	None
CABLE.....	3/4" 6 x 19	CABLE DAMAGE.....	None
	WRC 2 at 30" above pavement.	POST DAMAGE.....	20 Damaged - 1 Pulled Out
POST FOOTING.....	Design D	POST FOOTING DAMAGE.....	5 Cracked
POST SPACING.....	8' O.C.	MAX. DYNAMIC DEFLECTION OF CABLES.....	6'
LENGTH OF INSTALLATION.....	600'	VEHICLE DECELERATION (PEAK LONG).....	4 G's
GROUND CONDITION.....	Dry	VEHICLE DAMAGE.....	\$ 350

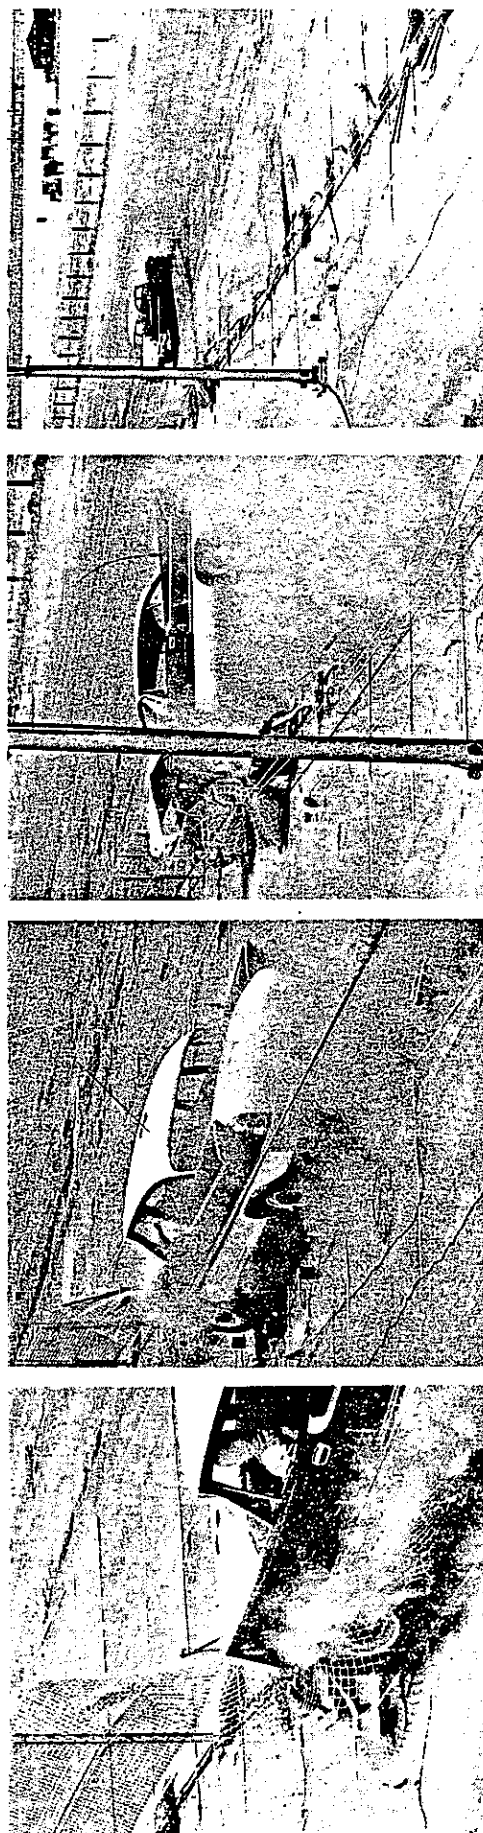
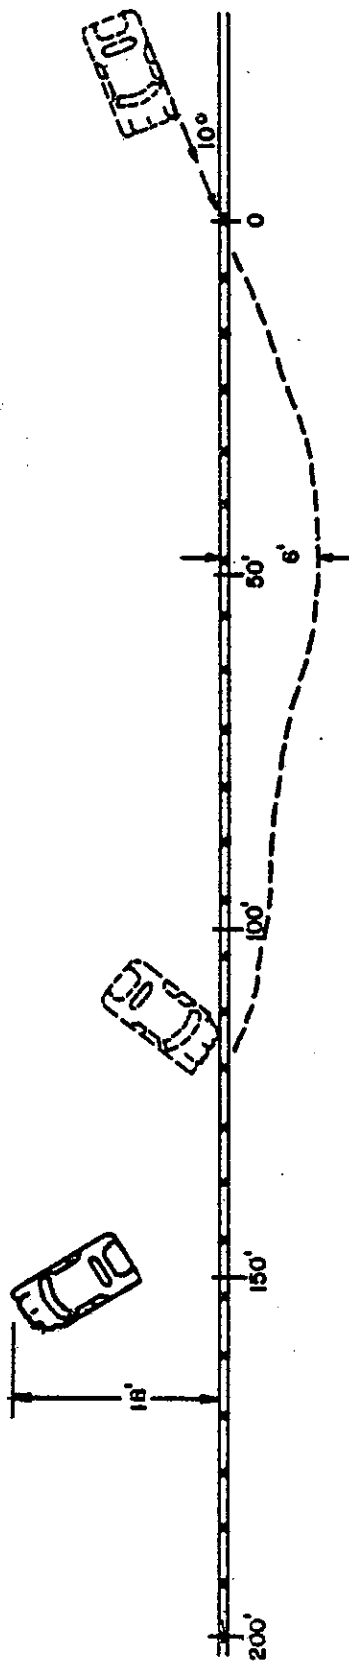
FENCE.....	48" chain link at 9" above pavement.	FENCE DAMAGE.....	136' damaged	TEST NO.....	4
CABLE.....	3/4" 7 x 7 2 at 30" above pavement.	CABLE FITTING DAMAGE.....	1 turnbuckle slightly bent	DATE.....	6-26-61
POST FOOTING.....	Design C	CABLE DAMAGE.....	none	VEHICLE.....	Dodge 59 Sedan
POST SPACING.....	8' O.C.	POST DAMAGE.....	17 damaged--1 pulled out	SPEED.....	76 MPH
LENGTH OF INSTALLATION.....	600'	POST FOOTING DAMAGE.....	16 cracked--1 failed	IMPACT ANGLE.....	10°
GROUND CONDITION.....	Dry	MAX DYNAMIC DEFLECTION OF CABLES.....	.6'	VEHICLE WEIGHT... 4300 lbs.	
		VEHICLE DECELERATION (PEAK LONG).....	3.6 g's	(W/DUMMY & INSTRUMENTATION)	
		VEHICLE DAMAGE.....	\$700

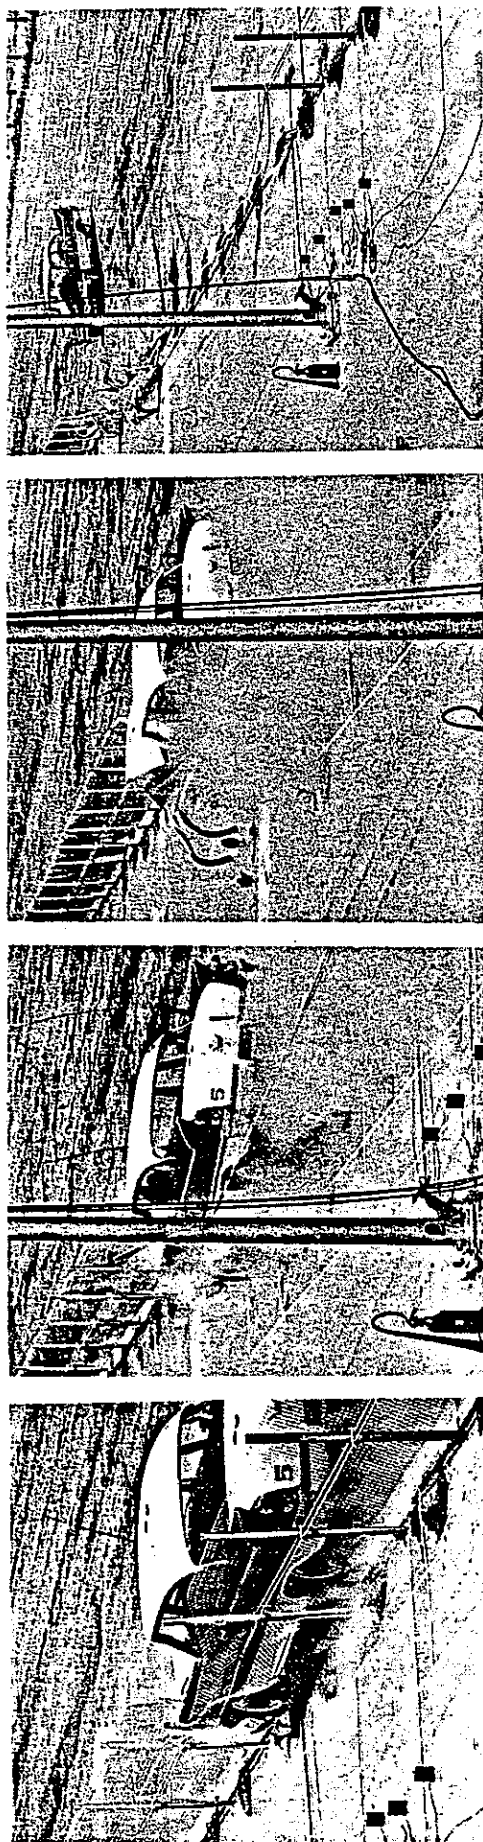
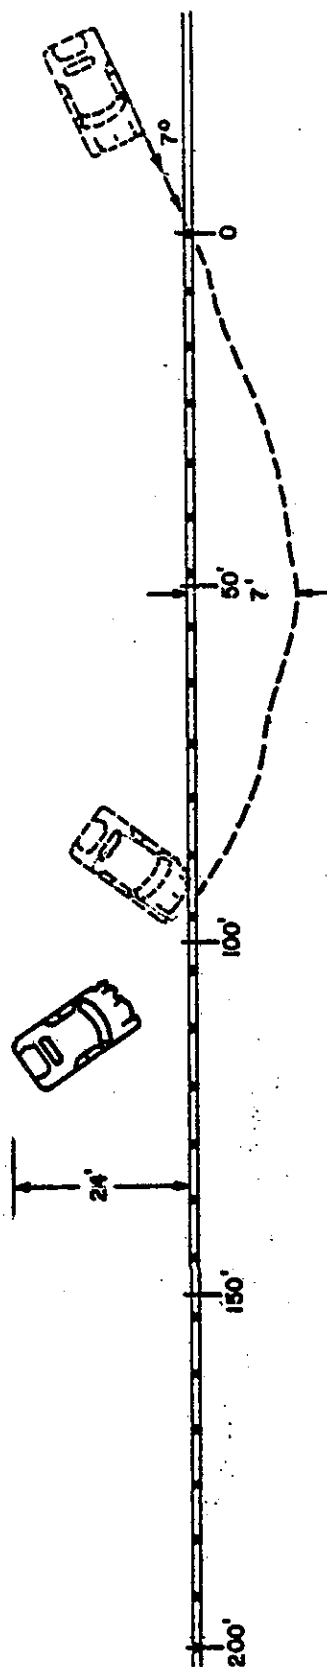
TEST NO..... 5
DATE..... 6-30-61
VEHICLE..... Dodge 59 Sedan
SPEED..... 84 MPH
IMPACT ANGLE..... 70
VEHICLE WEIGHT... 4300 lbs.
(W/DUMMY & INSTRUMENTATION)

FENCE DAMAGE..... 112' damaged
CABLE FITTING DAMAGE..... 1 deadend failed
CABLE DAMAGE..... none
POST DAMAGE..... 15 damaged-2 pulled out
POST FOOTING DAMAGE 10 cracked
MAX. DYNAMIC DEFLECTION OF CABLES.. 7'
VEHICLE DECELERATION (PEAK LONG).. 4.8 g's
VEHICLE DAMAGE..... \$ 350

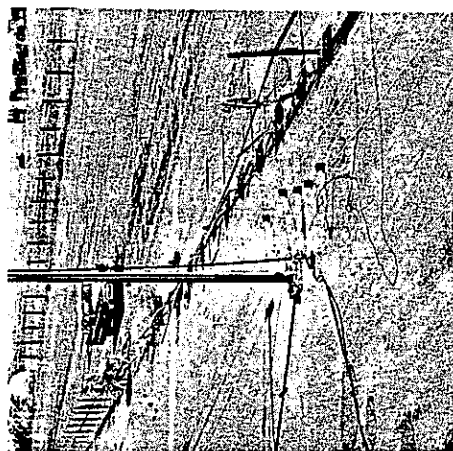
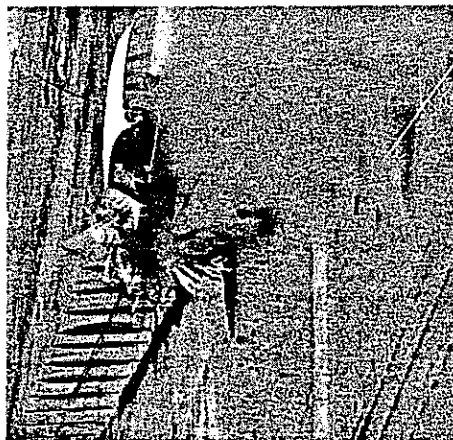
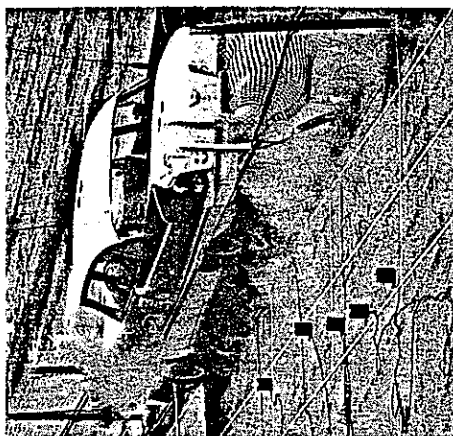
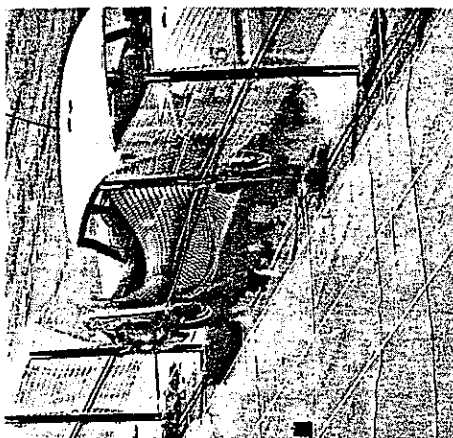
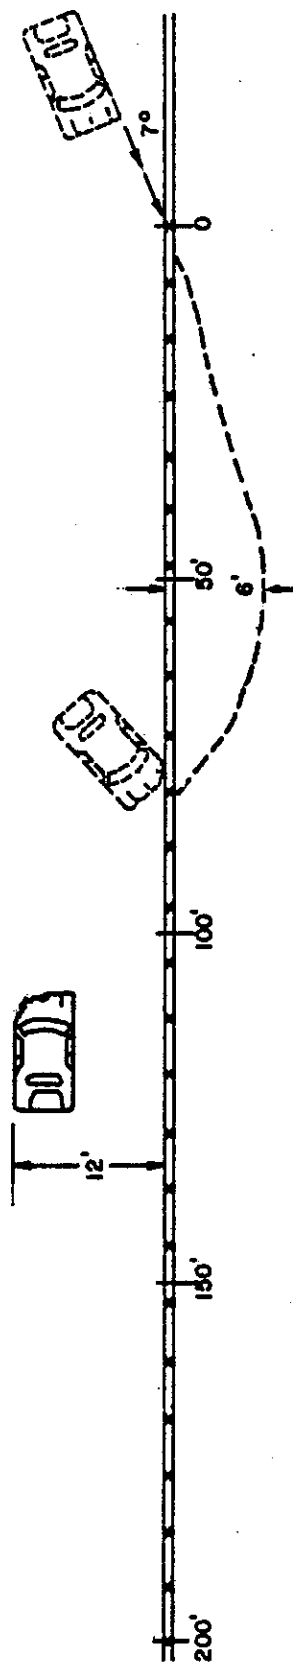
FENCE DAMAGE... 136' expanded metal damaged

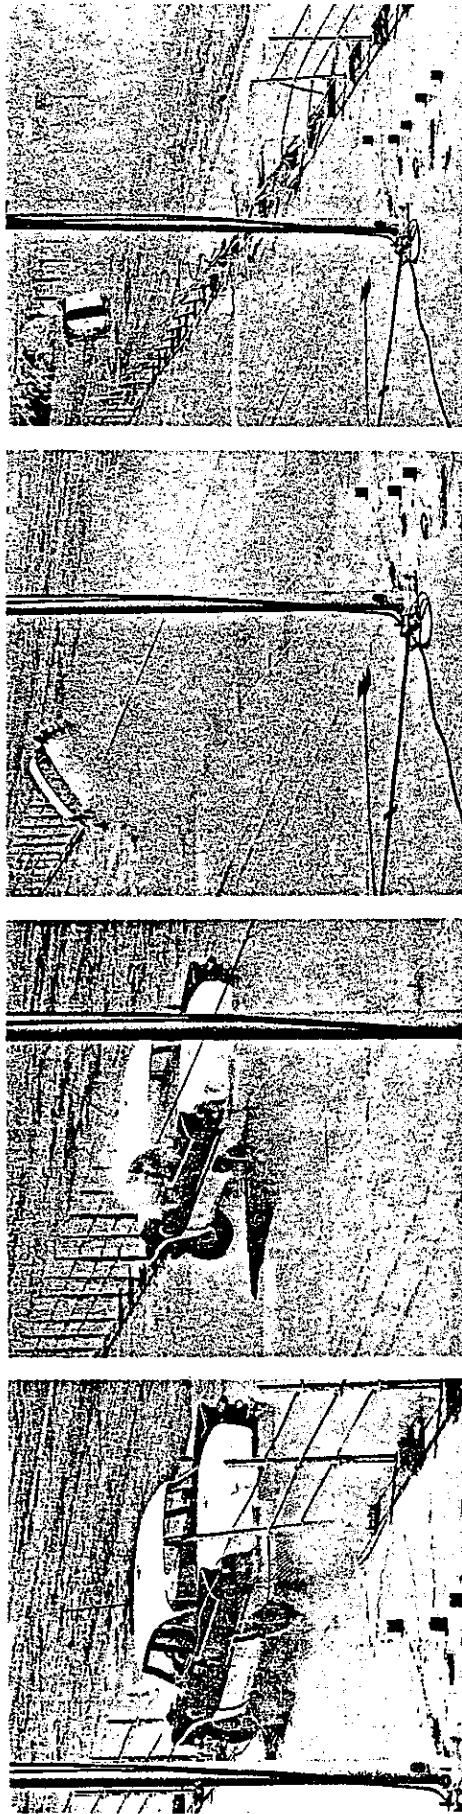
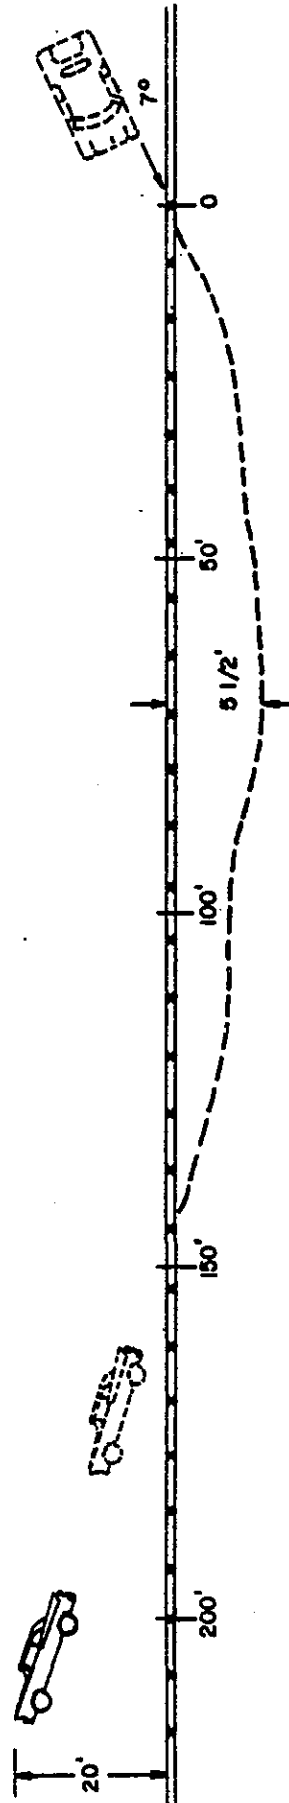
TEST NO.....7
DATE.....7-14-61
VEHICLE.....Dodge 59 Sedan
SPEED.....77 MPH
IMPACT ANGLE.....7°
VEHICLE WEIGHT... 4300 lbs.
(W/DUMMY & INSTRUMENTATION)

FENCE DAMAGE.....184' damaged
CABLE FITTING DAMAGE.....preformed splice failed
CABLE DAMAGE.....none
POST DAMAGE.....19 damaged
POST FOOTING DAMAGE.....12 cracked
MAX. DYNAMIC DEFLECTION OF CABLES . 5 1/2'
VEHICLE DECELERATION (PEAK LONG) . 6.8 g's
VEHICLE DAMAGE.....Total loss

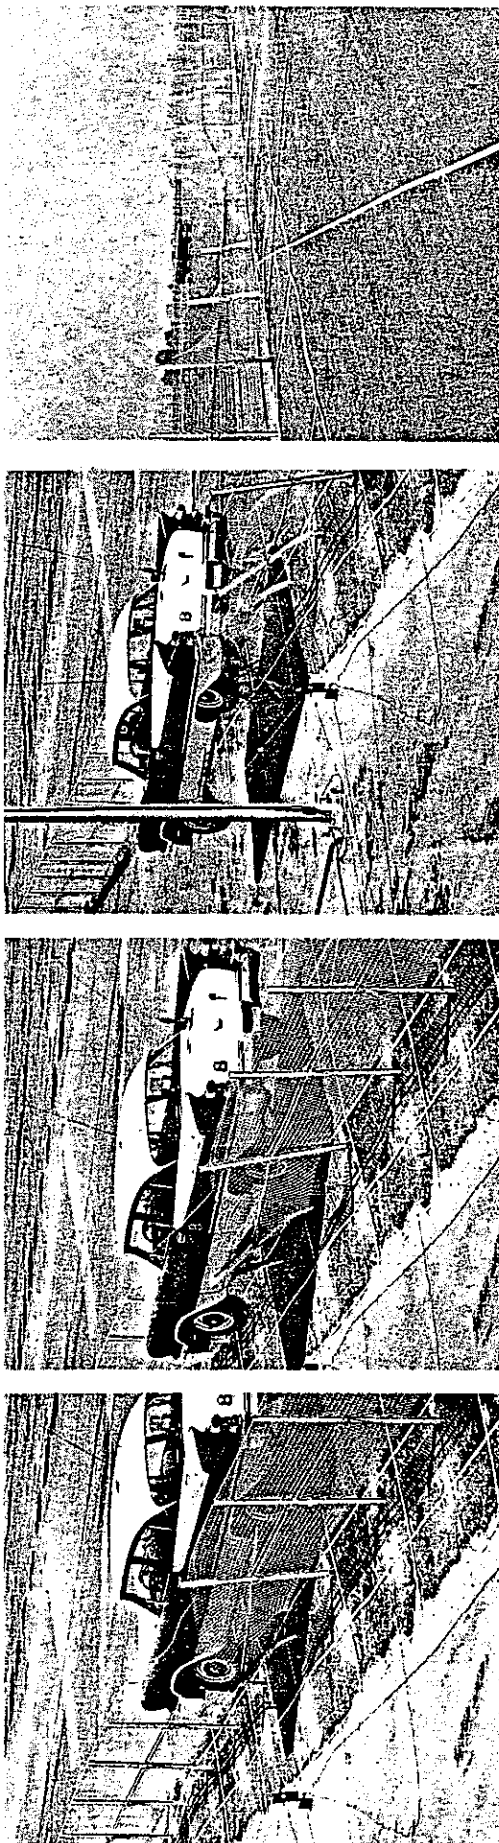
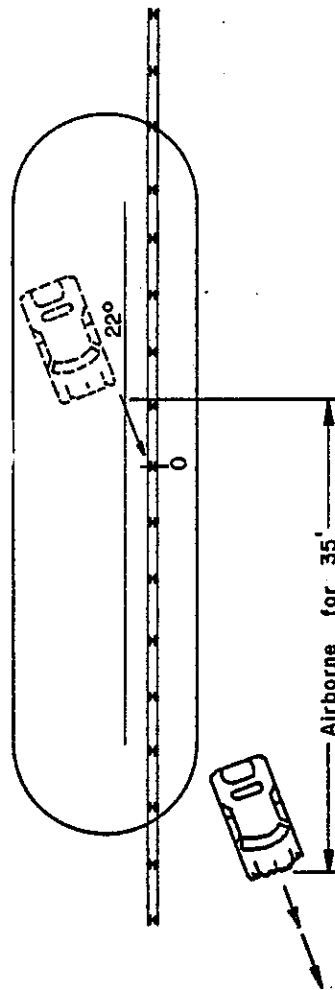
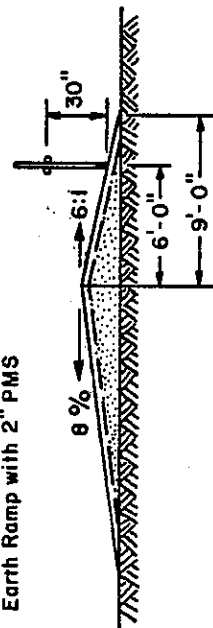
TEST NO. 8
 DATE 8-18-61
 VEHICLE Dodge 59 Sedan
 SPEED 74 MPH
 IMPACT ANGLE 22°
 VEHICLE WEIGHT ... 4300 lbs.
 (W/DUMMY & INSTRUMENTATION)

FENCE DAMAGE 35' damaged
 CABLE FITTING DAMAGE none
 CABLE DAMAGE none
 POST DAMAGE 7 damaged
 POST FOOTING DAMAGE none
 MAX. DYNAMIC DEFLECTION OF CABLES... Vehicle jumped barrier
 VEHICLE DECELERATION (PEAK LONG.) ... 1.7 G's (at end of jump)
 VEHICLE DAMAGE \$ 150

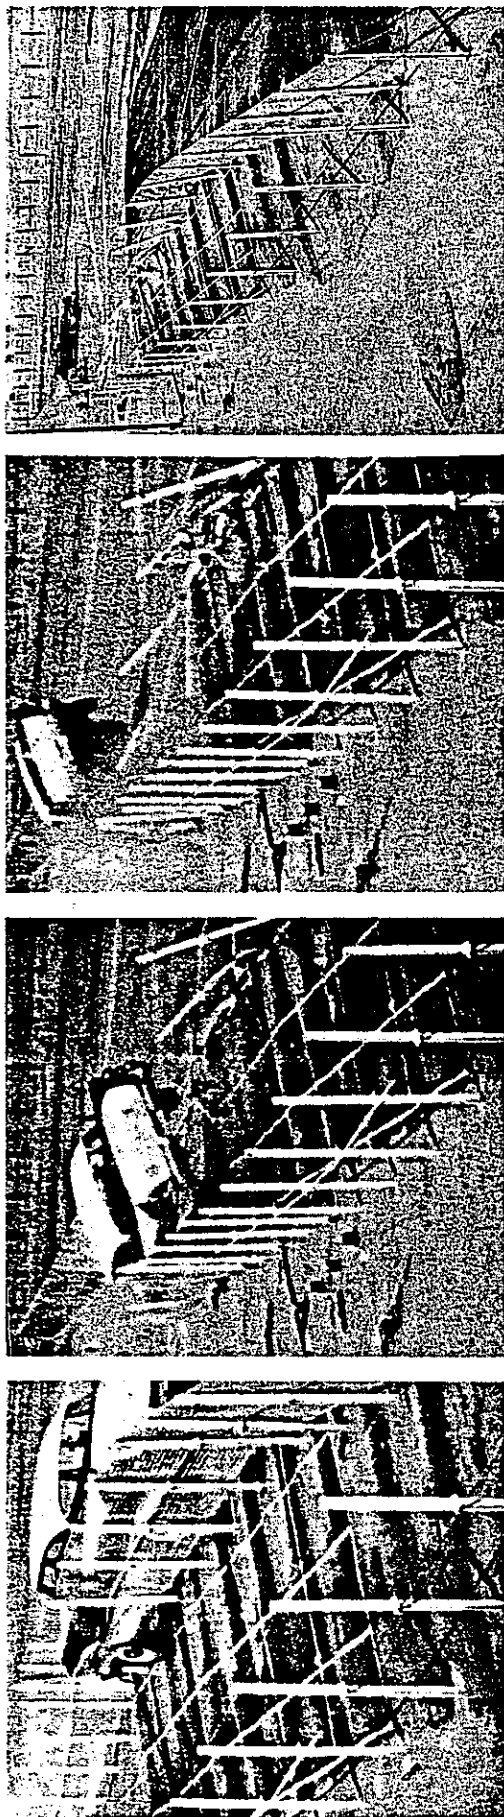
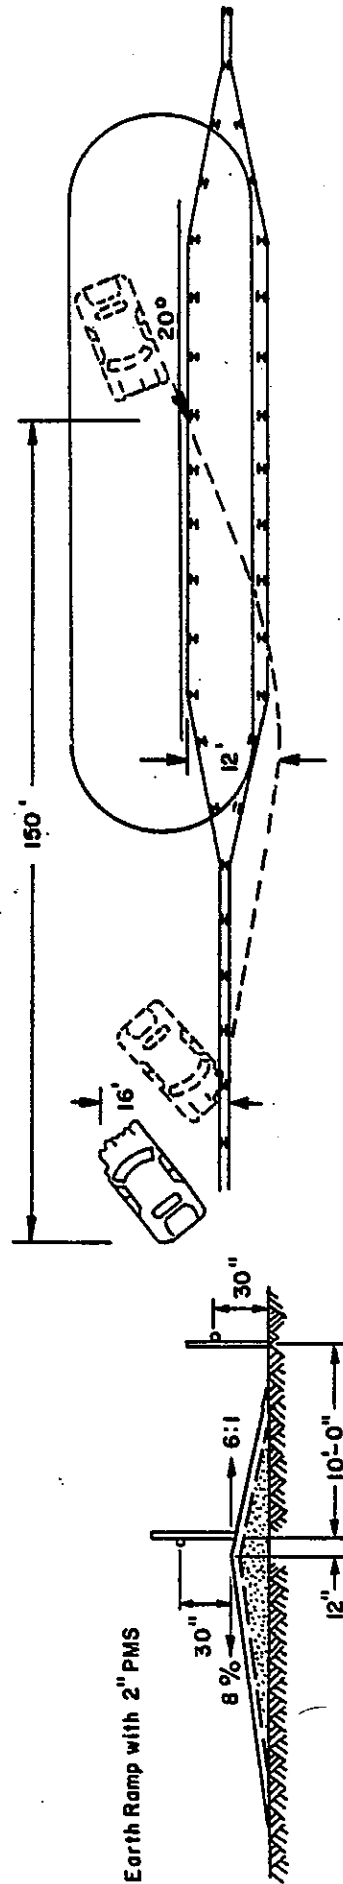
FENCE.....	48" chain link at 9" above pavement.	FENCE DAMAGE	136' damaged	TEST NO.....	9
CABLE.....	3/4" 6 x 19 IWRC 2 at 30" above pavement.	CABLE FITTING DAMAGE.....	none	DATE.....	9-29-61
POST FOOTING.....	Design B	CABLE DAMAGE.....	none	VEHICLE.....	Dodge 59 Sedan
POST SPACING.....	8' O.C.	POST DAMAGE.....	22 damaged - 11 slightly bent	SPEED.....	82 MPH
LENGTH OF INSTALLATION.....	400'	POST FOOTING DAMAGE.....	7 anchors cracked	IMPACT ANGLE.....	20°
GROUND CONDITION.....	Dry	MAX. DYNAMIC DEFLECTION OF CABLES.....	12'	VEHICLE WEIGHT.....	4300 lbs.
		VEHICLE DAMAGE.....	\$ 750	(W/DUMMY & INSTRUMENTATION)
